REPAIR INSTRUCTION NO. RI-1078-93/1

G 115E / EG all as affected

Repair of hinge bracket attachment points – FLAPS

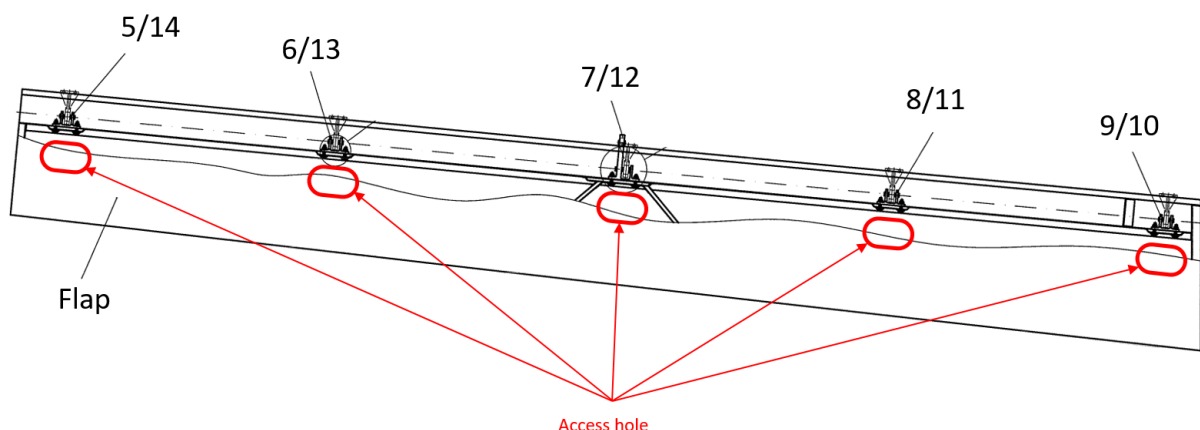
Figure 1: Flap Access Holes and Hinge Bracket Locations (LH shown, RH mirrored)

Note: If the access hole at location 7/12 is cut into the lower flap surface, it might be necessary to grind the upper shell locally for the installation of the bolts, refer to Figure 4.

CAUTION: At location 7/12 a 6mm thick repair plate (instead of 4mm) is installed with longer bolts of a higher strength category.
